NASA Technical Paper 1481

Light Airplane Crash Tests at Three Pitch Angles

Victor L. Vaughan, Jr., and Emilio Alfaro-Bou

NOVEMBER 1979

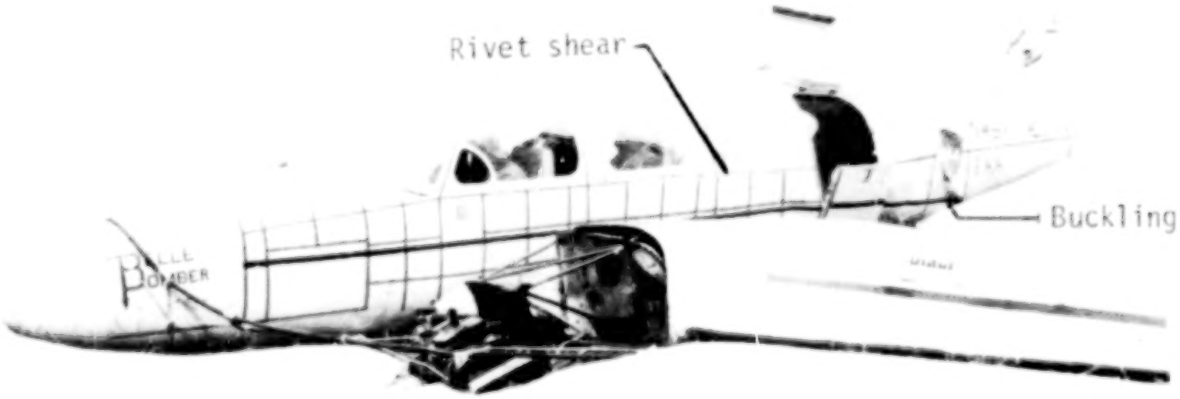
Flat test.- The photograph of the test specimen for the flat test (fig. 12(b)) shows only skin wrinkles in the forward section of the airplane specimen. The initial contact of the fuselage with the ground was in the vicinity of the door. The transverse expansion of the fuselage caused separation of the skin under the windows, as in the pitch-down test, but the degree of separation was less. More severe lower fuselage damage was sustained in the vicinity of the third window and extended rearward through the baggage compartment aft of the door (fig. 14). Separation of the skin along the bottom of the windows on the starboard side of the fuselage is shown in figure 14(a). As in the pitch-down test, the port side sustained more rivet-shear damage along the windows than the starboard side, thus supporting the conclusion that the door opening weakened the fuselage on the port side. In this test, the door opened immediately after the first ground contact.

(b) Flat test specimen.

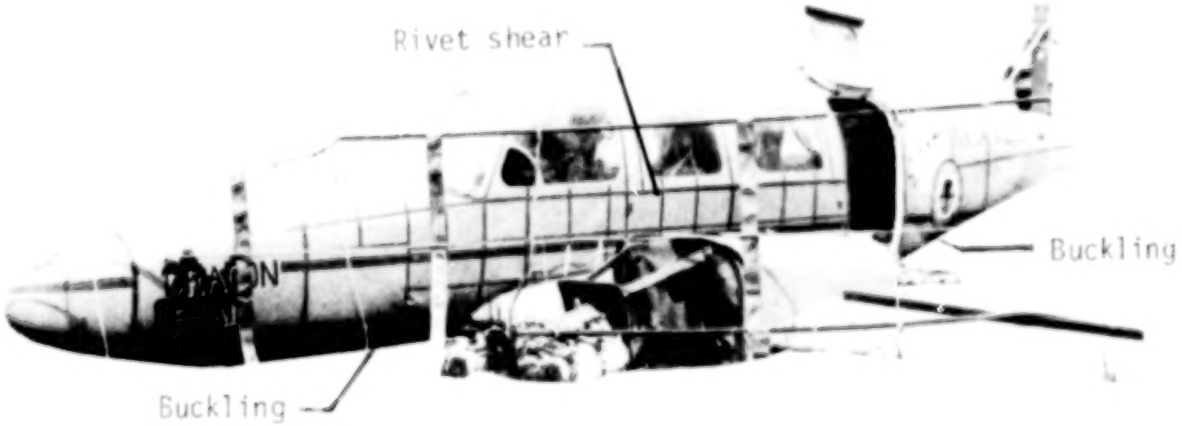
Pitch-up test.- The photograph of the test specimen for the pitch-up test (fig. 12(c)) shows very little damage to the port side of the specimen. Small wrinkles or buckling can be noted at the nose near the fire wall and aft of the door. Separation of the skin under the windows due to rivet shear is shown in figure 15(a), but was not nearly as severe as in the pitch-down and flat tests. The primary impact occurred along the aft fuselage section at the baggage compartment. The separation and buckling of the skin on the bottom of the fuselage at the frame forming the aft edge of the door was a result of the tensile loading in the bottom of the specimen as the aft end of the specimen contacted the ground. Separation of the skin on the starboard side of the specimen is shown in figure 15(b). The door opened immediately after initial ground contact as it did in the flat test.

(c) Pitch-up test specimen.

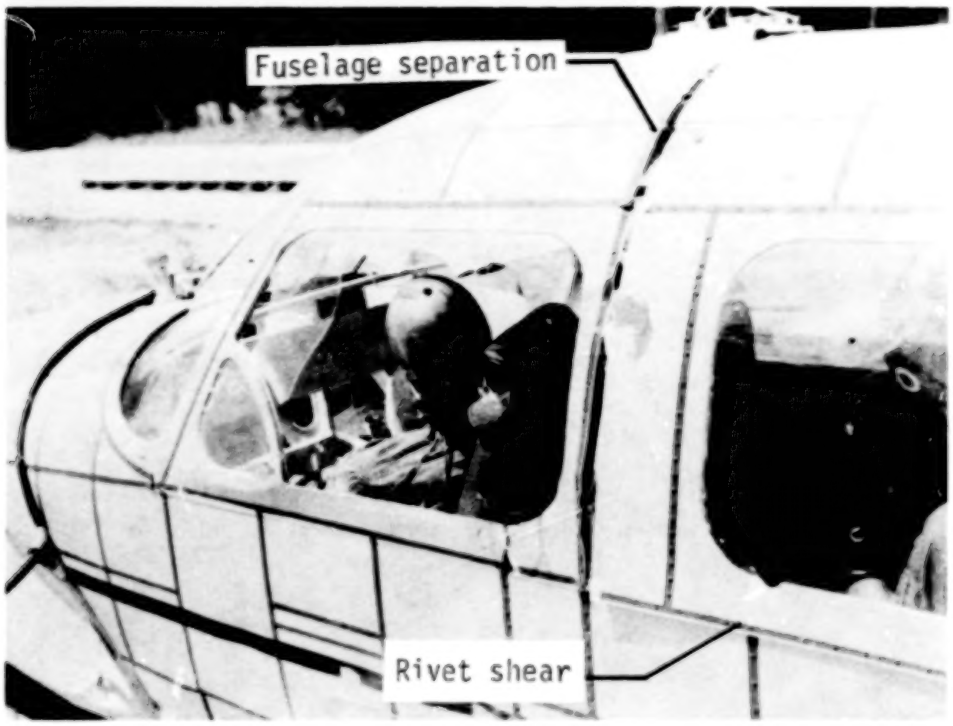
L-74-2632.1

A close-up view of the window section of the specimen is presented in figure 13(a). The separation in the fuselage at the frame just aft of the pilot is directly over the main wing spar that passes through the fuselage. This separation occurred as the specimen tail reached its lowest position during downward rotation, which caused the top of the fuselage to go into tensile loading, thus shearing the rivets that attach the skin to the frame.

(a) Separation of fuselage on port side of fuselage.

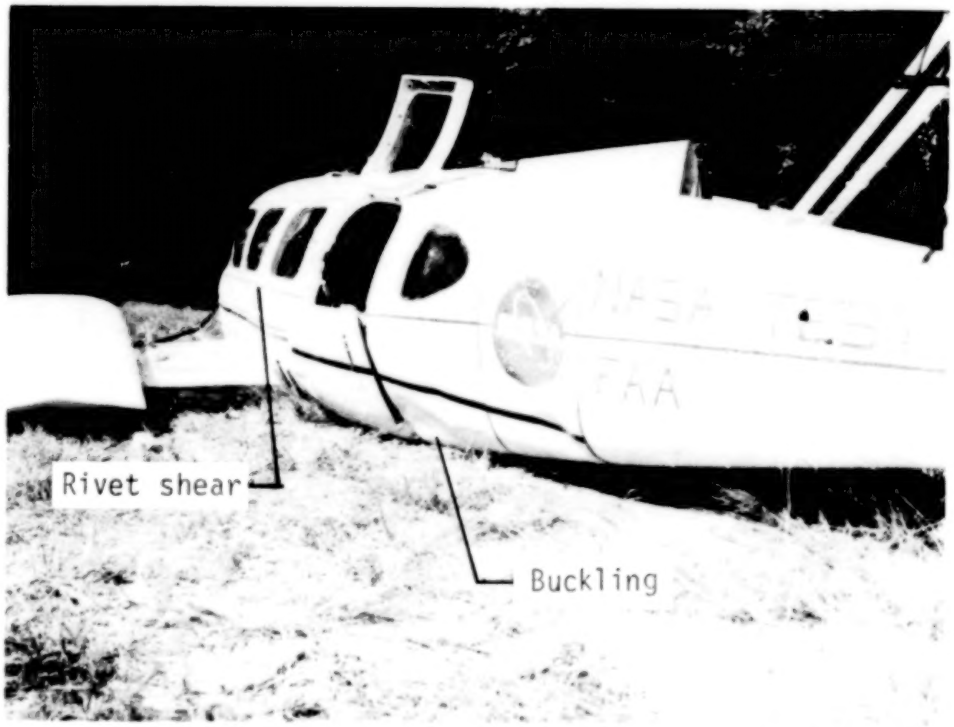
L-74-8073.1

(b) Aft section damage on port side of fuselage.

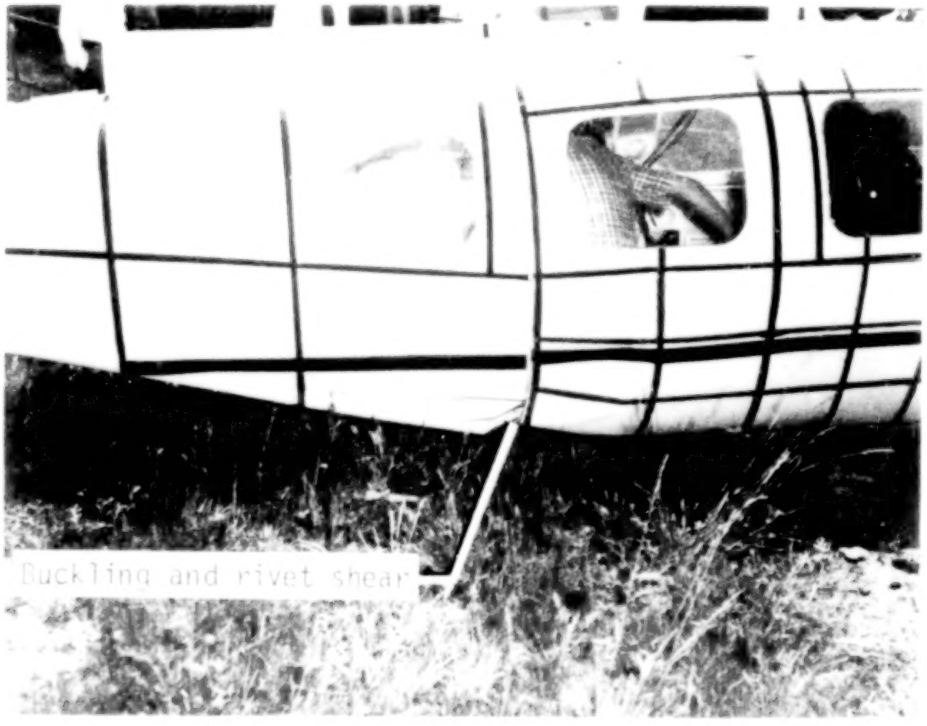
L-75-3749.1

(b) Aft section damage on starboard side of fuselage.

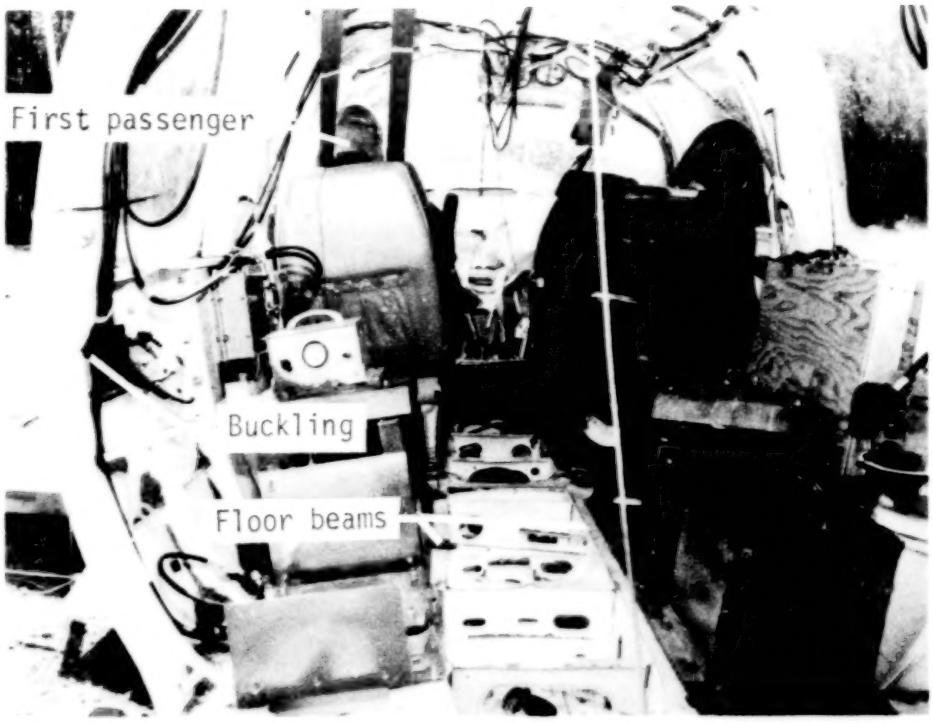
L-74-2642.1

Pitch-down test.- The photograph from the pitch-down test (fig. 16(a)) was taken from the aft end of the fuselage looking forward. The intrusion of the floor structure into the cabin is shown by the outward rotated position of the seats. Because of the circular shape of the bottom of the fuselage, the out-

(a) View looking forward.

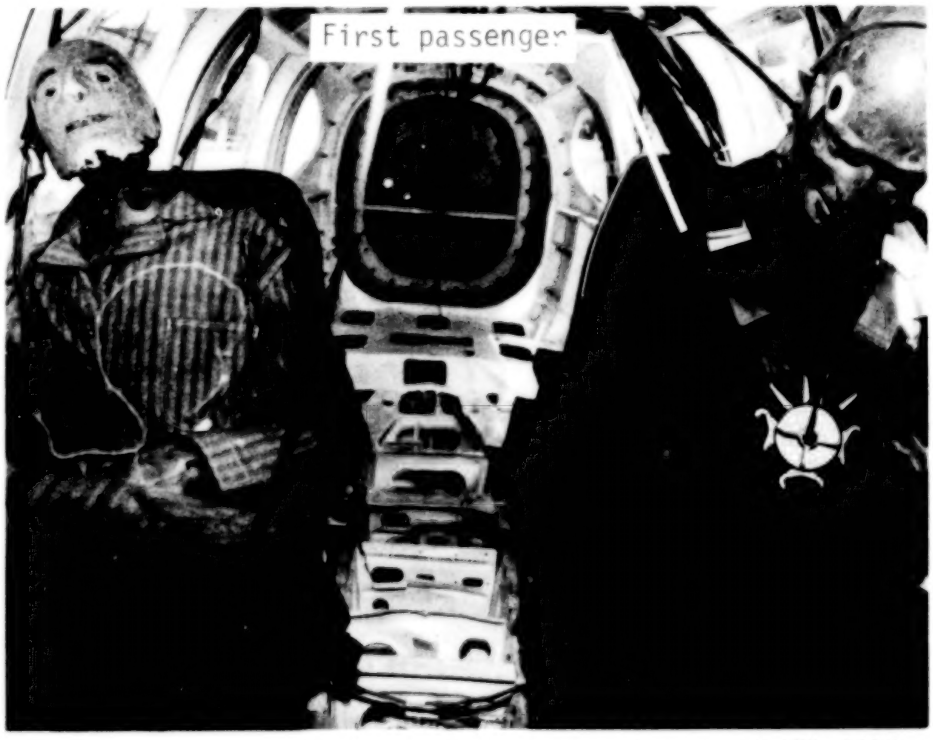
L-74-2638.1

(b) View looking aft.

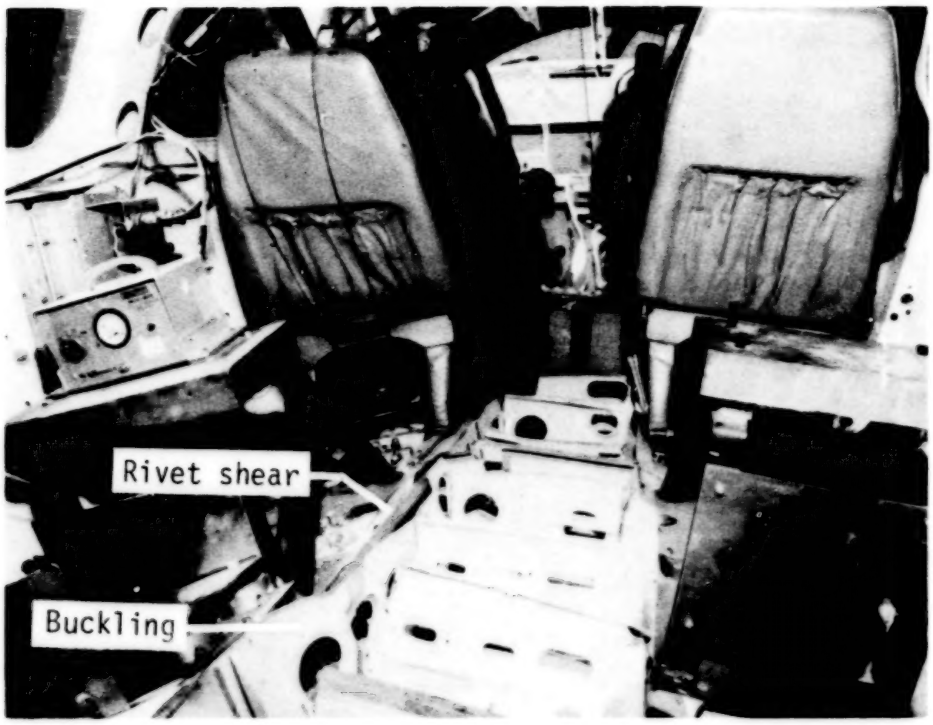
L-74-8078.1

Flat test.- The photograph from the flat test (fig. 17(a)) was taken from the aft end of the fuselage looking forward. The outboard rotated position of the seats is much more pronounced than in the pitch-down test. The floor structure was pushed upward, with buckling and rivet-shear failures throughout the floor area. The longitudinal floor beams, which are fabricated from flat stock and extrusions riveted together, separated along the rivet lines. The photograph taken looking through the doorway at the structural damage in the vicinity of the fuselage where first ground contact occurred (fig. 17(b)) indicated that the floor structural damage was extensive and included buckling, rivet-shear failure, breaking, and tearing of the structure. This damage area extended back to the frame of the baggage compartment farthest aft, as shown in figure 17(c). The photograph (fig. 17(d)) shows a break in the main wing spar near the center of the fuselage.

(a) View looking forward.

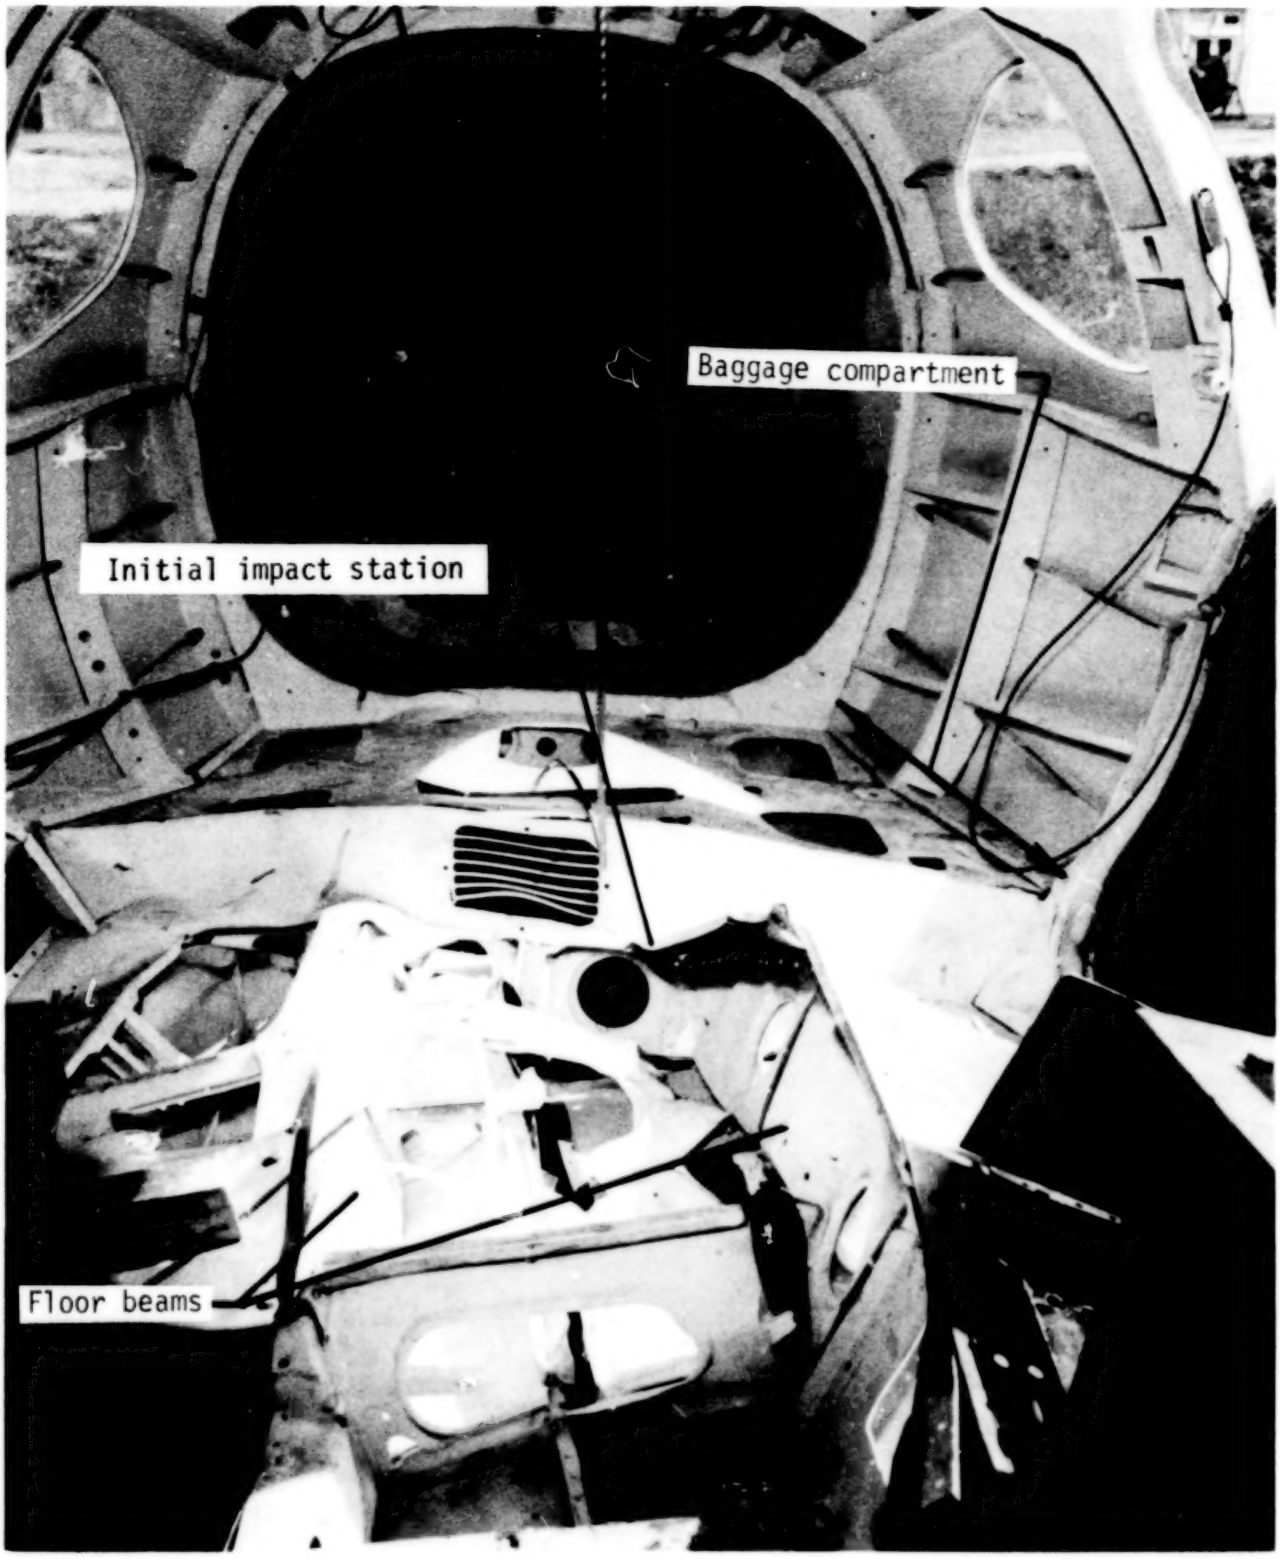
(c) View looking aft.

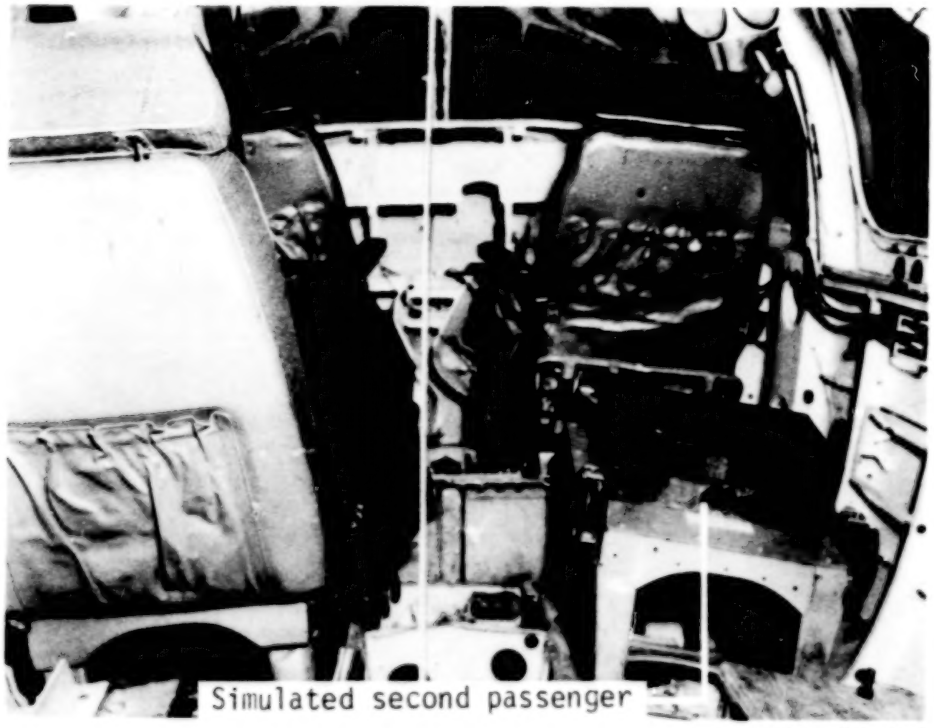
L-75-3760.1

Pitch-up test.- The photograph from the pitch-up test that was taken from the aft end of the fuselage looking forward (fig. 18(a)) shows the same type of outboard-rotated position of the seats as previously noted. The second-passenger dummy used in the previous tests was simulated with lead masses in this test. Although the external pictures (fig. 15) indicated less structural damage than in the pitch-down and flat tests, the pictures of the internal structure in the vicinity of the door and baggage compartment (fig. 18(b)) show damage similar to the flat test. The floor damage in the passenger section of the fuselage (fig. 18(c)) shows some structural buckling, rivet shear, and total failures of the cross members between the longitudinal beam, but little damage to the beams themselves.

(a) View looking forward.

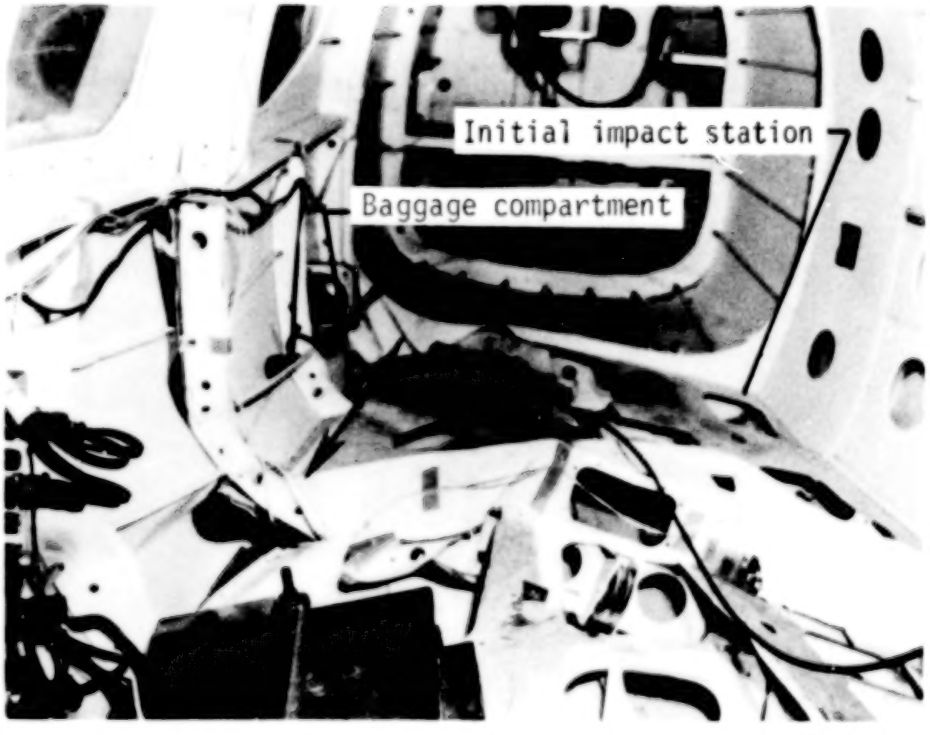
L-75-3759.1

(b) View looking aft.

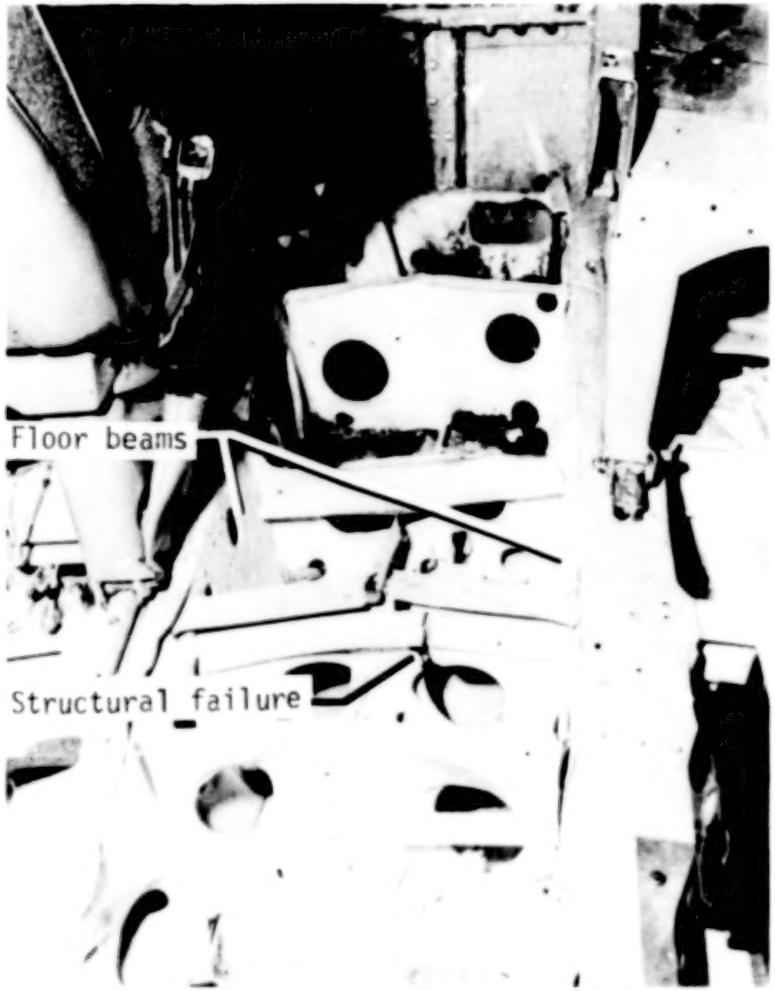
L-75-3748.1

(d) View of floor between first- and second-passenger seats.

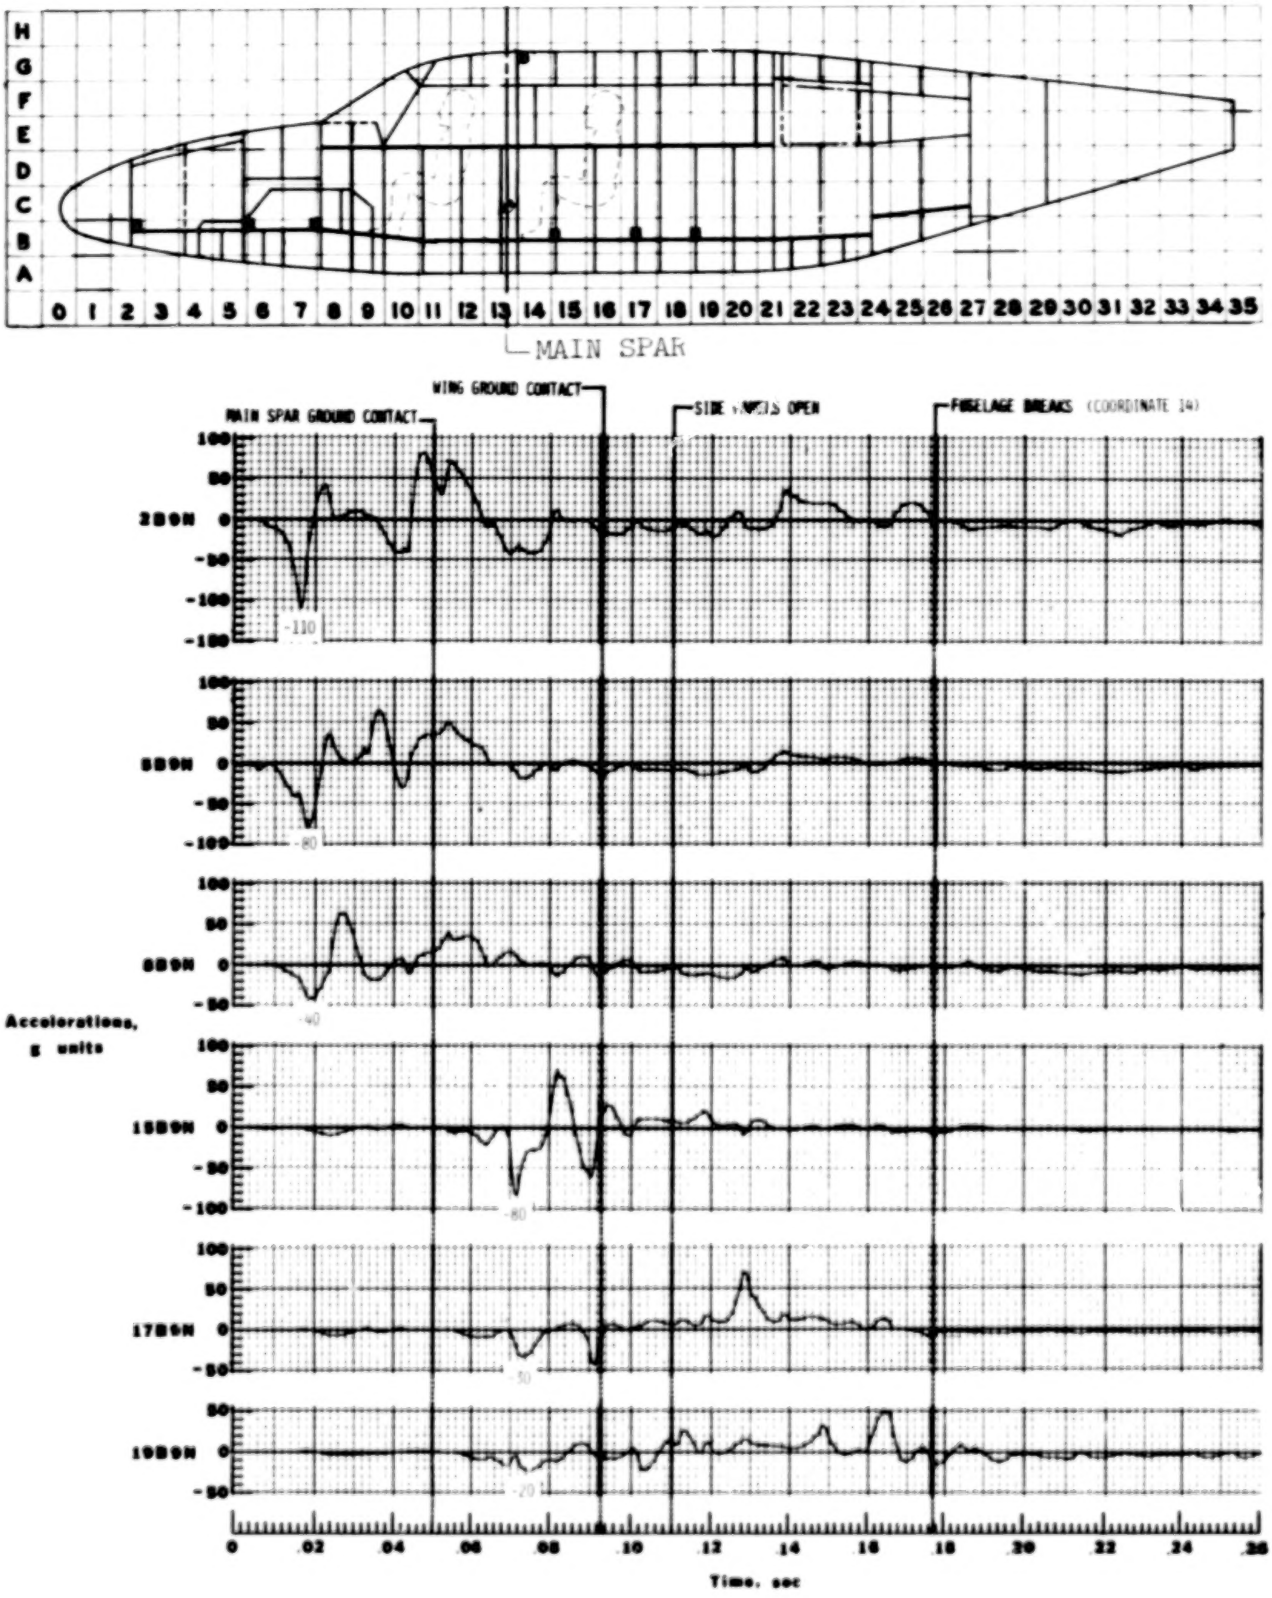
(a) Pitch-down test.

Pitch-down test.- The pitch-down test specimen made first ground contact in a -12° pitch attitude such that the first fuselage frame (2B9N) of figure 19(a) responded to the impact first, followed by the impact of consecutive frames back to the fire wall (8B9N). The acceleration histories show that the application of the major impact acceleration at the first frame peaked at 0.016 sec after ground contact, with a magnitude of -110g. The acceleration of the floor beam at the fire wall peaked at 0.019 sec, with a magnitude of -40g. The main spar contacted the ground at about 0.05 sec into the impact. During this time, the specimen continued to pitch to an attitude of -9°. The main spar acted as a fulcrum when it contacted the ground. This caused the angular velocity of the passenger compartment behind the spar to increase and the nose of the specimen to rotate off the ground, thus relieving all direct loadings in the nose section. The intensity of the accelerations decreased from -110g to -40g as the ground contact moved rearward to the spar. The floor from the spar (frame coordinate 13) through the third-passenger location (frame coordinate 19) was in ground contact within 0.08 sec after initial ground contact. During this time period, the spar buckled near the center of the cabin as the wing twisted and rotated down.

Pitch-down test.- The normal and longitudinal acceleration histories at the seat legs and in the dummy are presented in figures 23(a) and 23(b), respectively, for the pitch-down test. After the main spar contacted the impact surface (see fig. 19(a)) at 0.05 sec, the floor beam under the dummy experienced normal accelerations of -80g and -30g at the seat front and back legs, respectively. The floor on the window side experienced normal accelerations of -30g and -25g at the seat front and back legs, respectively. The accelerations peaked at about 0.073 sec into the impact. The dummy started to sink into the seat and move forward into the five-point harness restraint system within 0.02 sec after initial ground contact. The dummy experienced only small accelerations as he sank into the seat. The harness system began to tighten at about 0.08 sec into the impact, and the dummy's downward and forward motion was stopped at about 0.114 sec. The resulting delayed pelvic normal acceleration of -55g in the dummy is shown by the peak in the normal direction (fig. 23(a)) and to a greater extent in the longitudinal acceleration of -80g (fig. 23(b)) at 0.114 sec. The seat started to rotate outboard following the deformation of the floor structure at about 0.07 sec, and continued for 0.117 sec. The seat-leg and dummy accelerometers showed negligible accelerations after the seat stopped rotating.

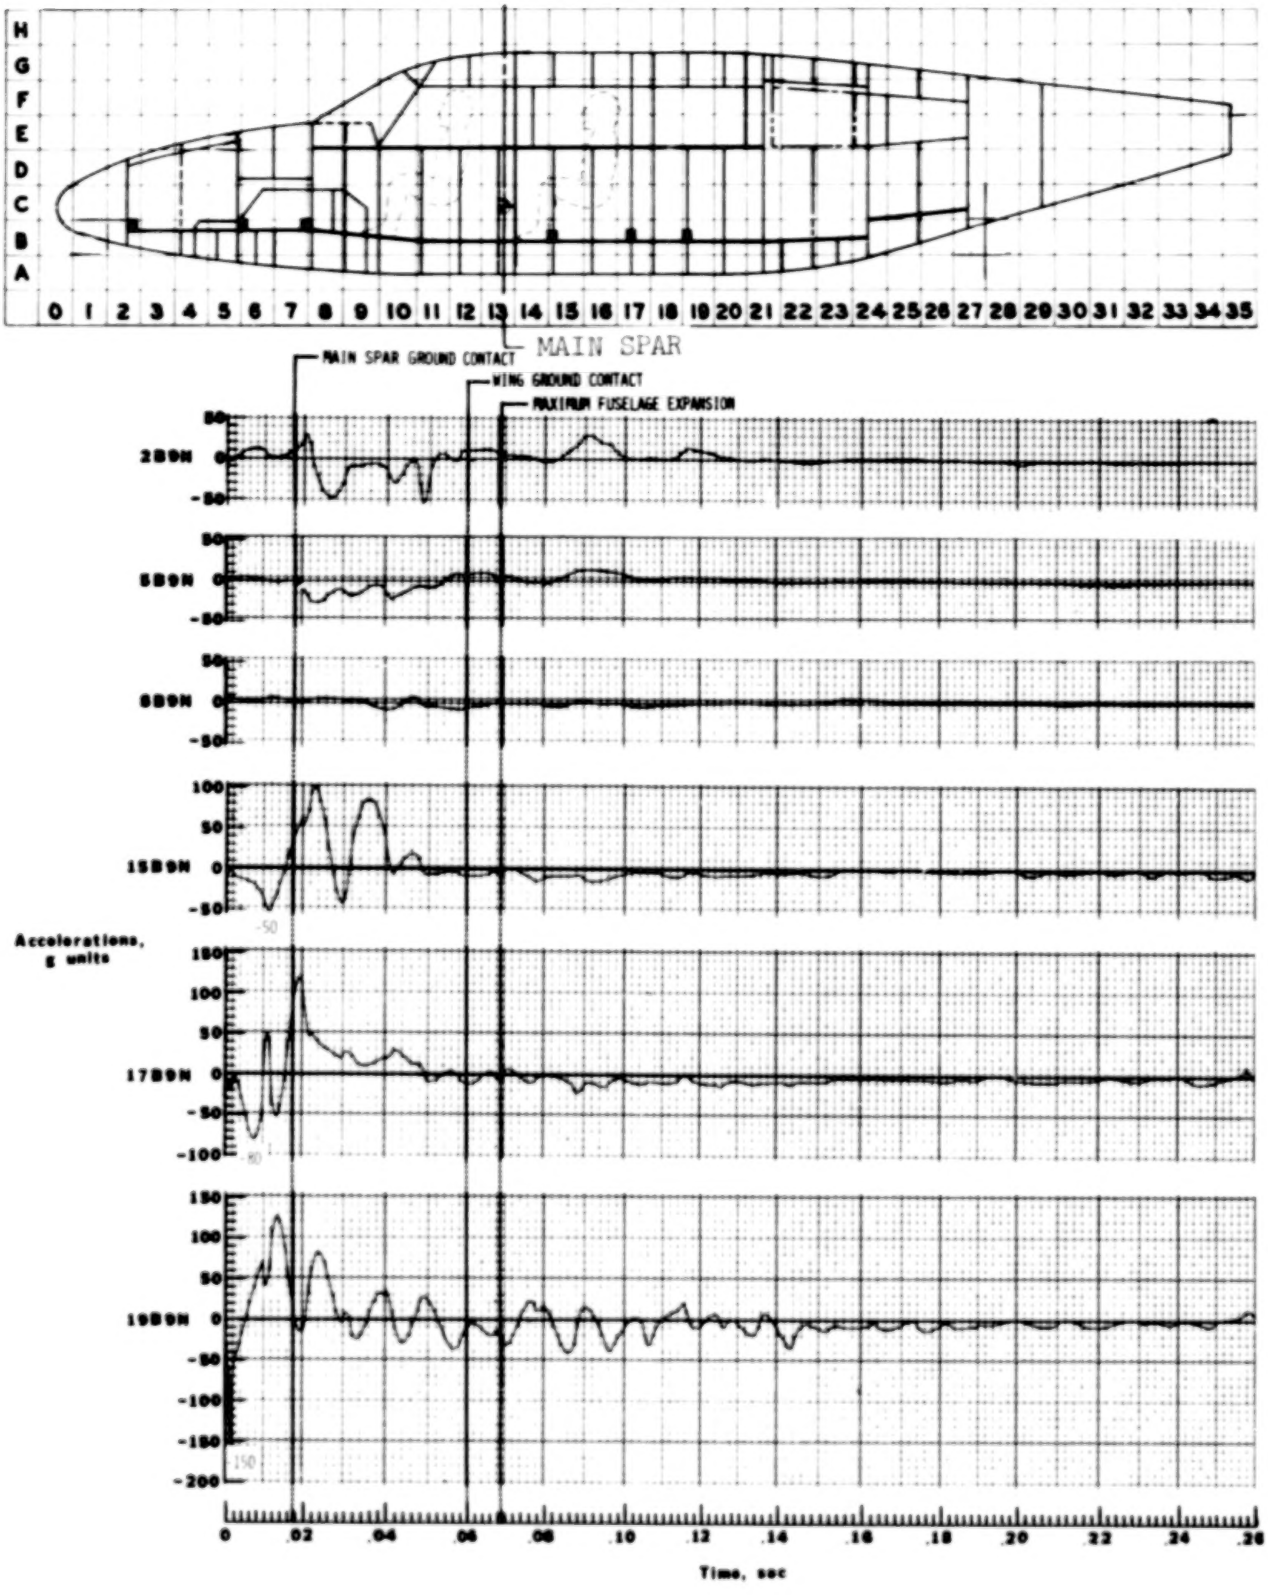
(b) Flat test.

Flat test.- The flat-test specimen made first ground contact in a 4° pitch attitude, which resulted in initial ground contact at grid coordinate 21. The accelerometer at 19B9N (see fig. 19(b)) responded on initial ground contact. The specimen pitch attitude changed less than 1° during impact. Loads were progressively applied to the floor beams such that the fire wall (8B9N) was the last frame to contact the ground at 0.032 sec after initial ground contact. Very high accelerations were experienced in the passenger compartment aft of the main spar, with the greatest acceleration of -150g occurring in the third- and fourth-passenger location. These passenger-compartment accelerations were considerably higher for the flat specimen (-150g to -50g) than for the pitch-down specimen (-80g to -20g). The accelerations at the fire wall (8B9N) were very small. The accelerations at the first frame (2B9N) and second frame (5B9N) in the nose of the airplane were transmitted through the floor beam and attached structure since those two frames did not contact the ground during impact. The intensity of the first peaks exhibited the same trend but in the reverse direction as that in the pitch-down test (i.e., the intensity decreased as the ground contact moved forward). Maximum fuselage expansion occurred at 0.069 sec when all vertical velocity of the structure had ceased. There are no indications in the acceleration data of the main wing spar breaking (see fig. 17(d)), even though there was complete failure in the upper flange of the spar.

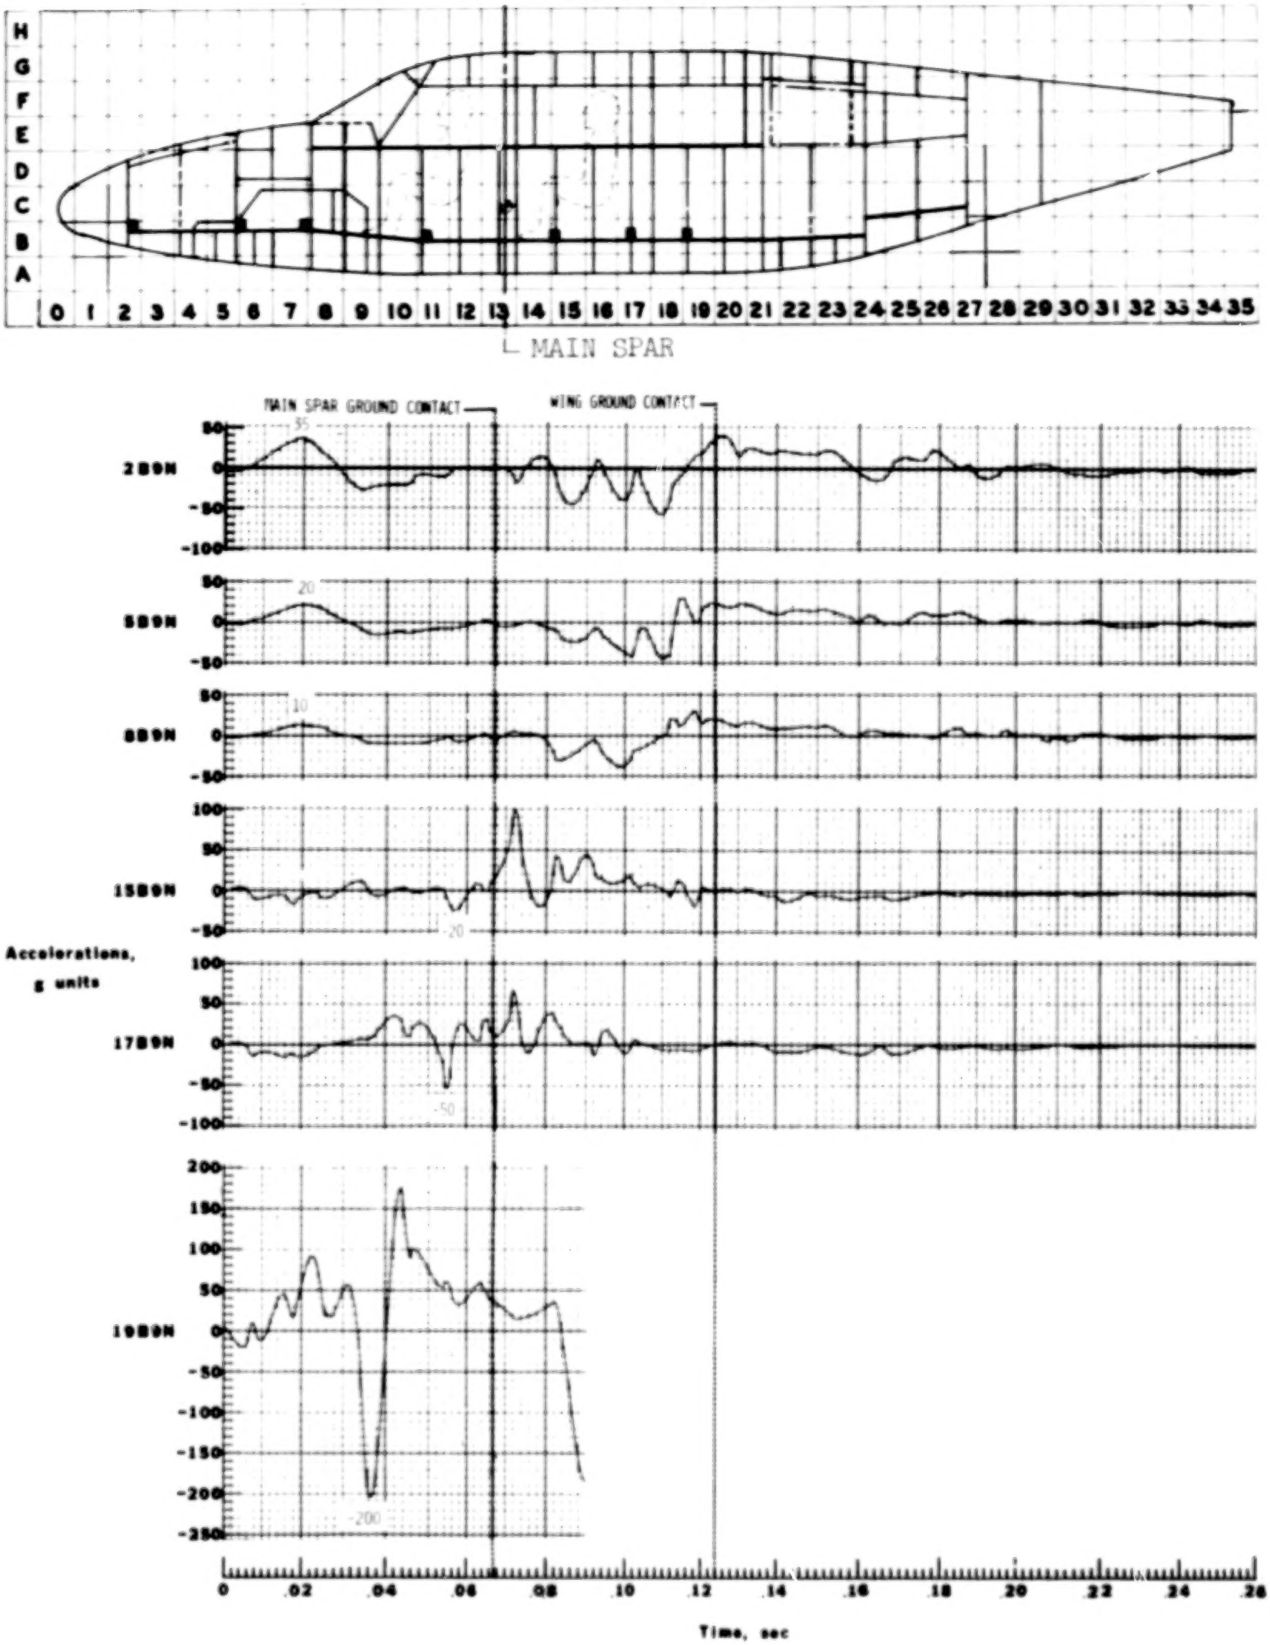
(c) Pitch-up test.

Pitch-up test.- The pitch-up test specimen made first ground contact along the slope of the lower surface of the tail section. The frame at grid coordinate 24 (fig. 19(c)) was extensively damaged on initial ground contact, and it took about 0.03 sec for the ground contact to move forward in the passenger compartment, when there was a major response at accelerometer 19B9N. The accelerations at this frame were very high (-200g), but as the ground contact moved further into the compartment, the accelerations at the succeeding frames were much lower (-50g to -20g) and of about the same magnitude as those of the flat test. It may be noted that the accelerations at the frames in the nose section (2B9N, 5B9N, and 8B9N) responded in the positive direction before the main spar contacted the ground at 0.067 sec into the impact. The accelerations of 35g, 20g, and 10g at frames 2B9N, 5B9N, and 8B9N, respectively, indicate a very high downward pitching rate as a result of the initial high nose-ground contact of 14° pitch. After the main spar contacted the ground, these same forward frames showed negative accelerations due to ground contact. By the time the wing tips made ground contact, the nose frames were already in ground contact, and the airplane continued to rock forward until only the nose section was in ground contact. Thereafter, all accelerations were very low as the airplane rocked back onto the bottom of the fuselage.

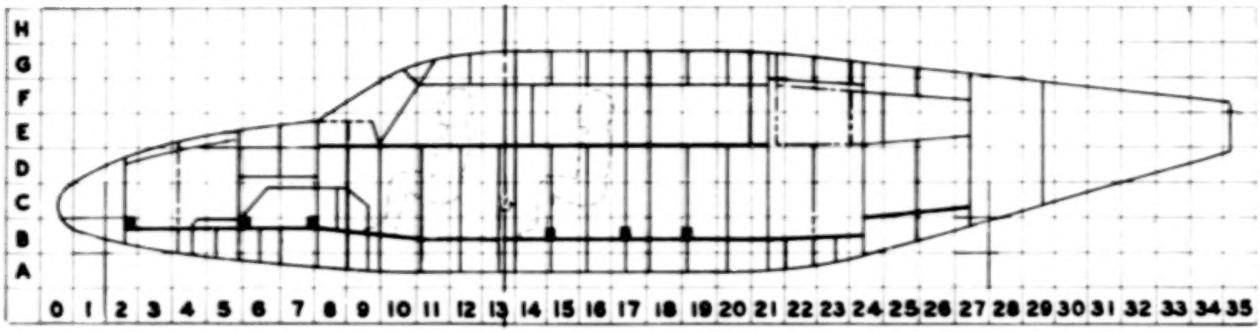
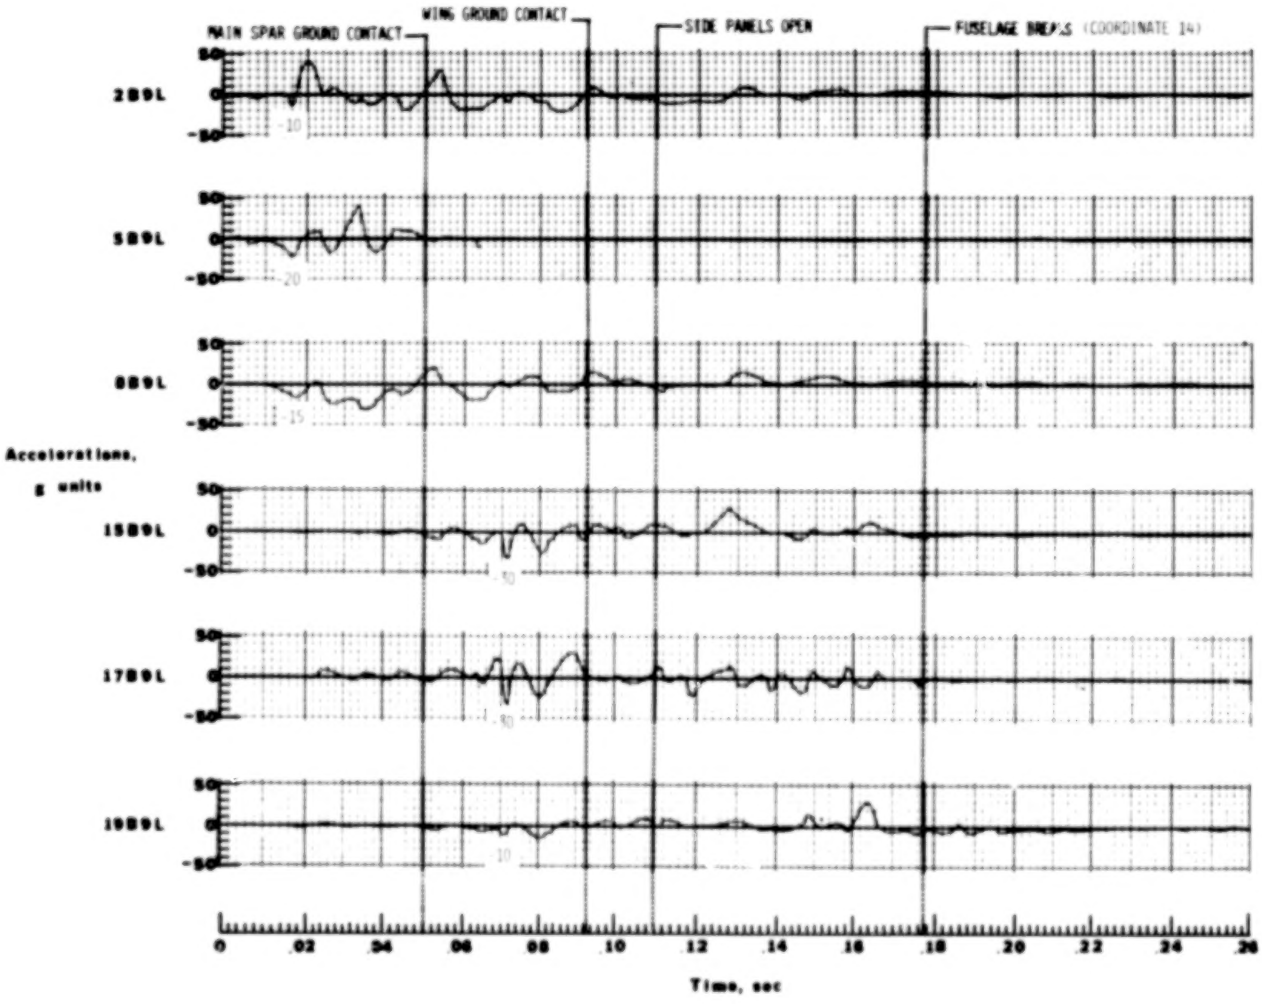
(a) Pitch-down test.

Pitch-down test.- Figure 20(a) shows the response of the longitudinal accelerometers to impact for the pitch-down test. The magnitude of accelerations in the nose (2B9L to 8B9L) was very low during the deformation of the nose structure, which ended at about 0.02 sec into the impact. The later peaks were associated with the rebound of the nose section and the acceleration transmitted through the structure. Behind the main spar, structural deformation was felt over a much longer time since ground contact at 19B9L started about 0.08 sec after initial ground contact and continued for a period of 0.065 sec, or until maximum fuselage expansion at about 0.145 sec. The longitudinal acceleration traces do not show definite indication of specific structural failures.

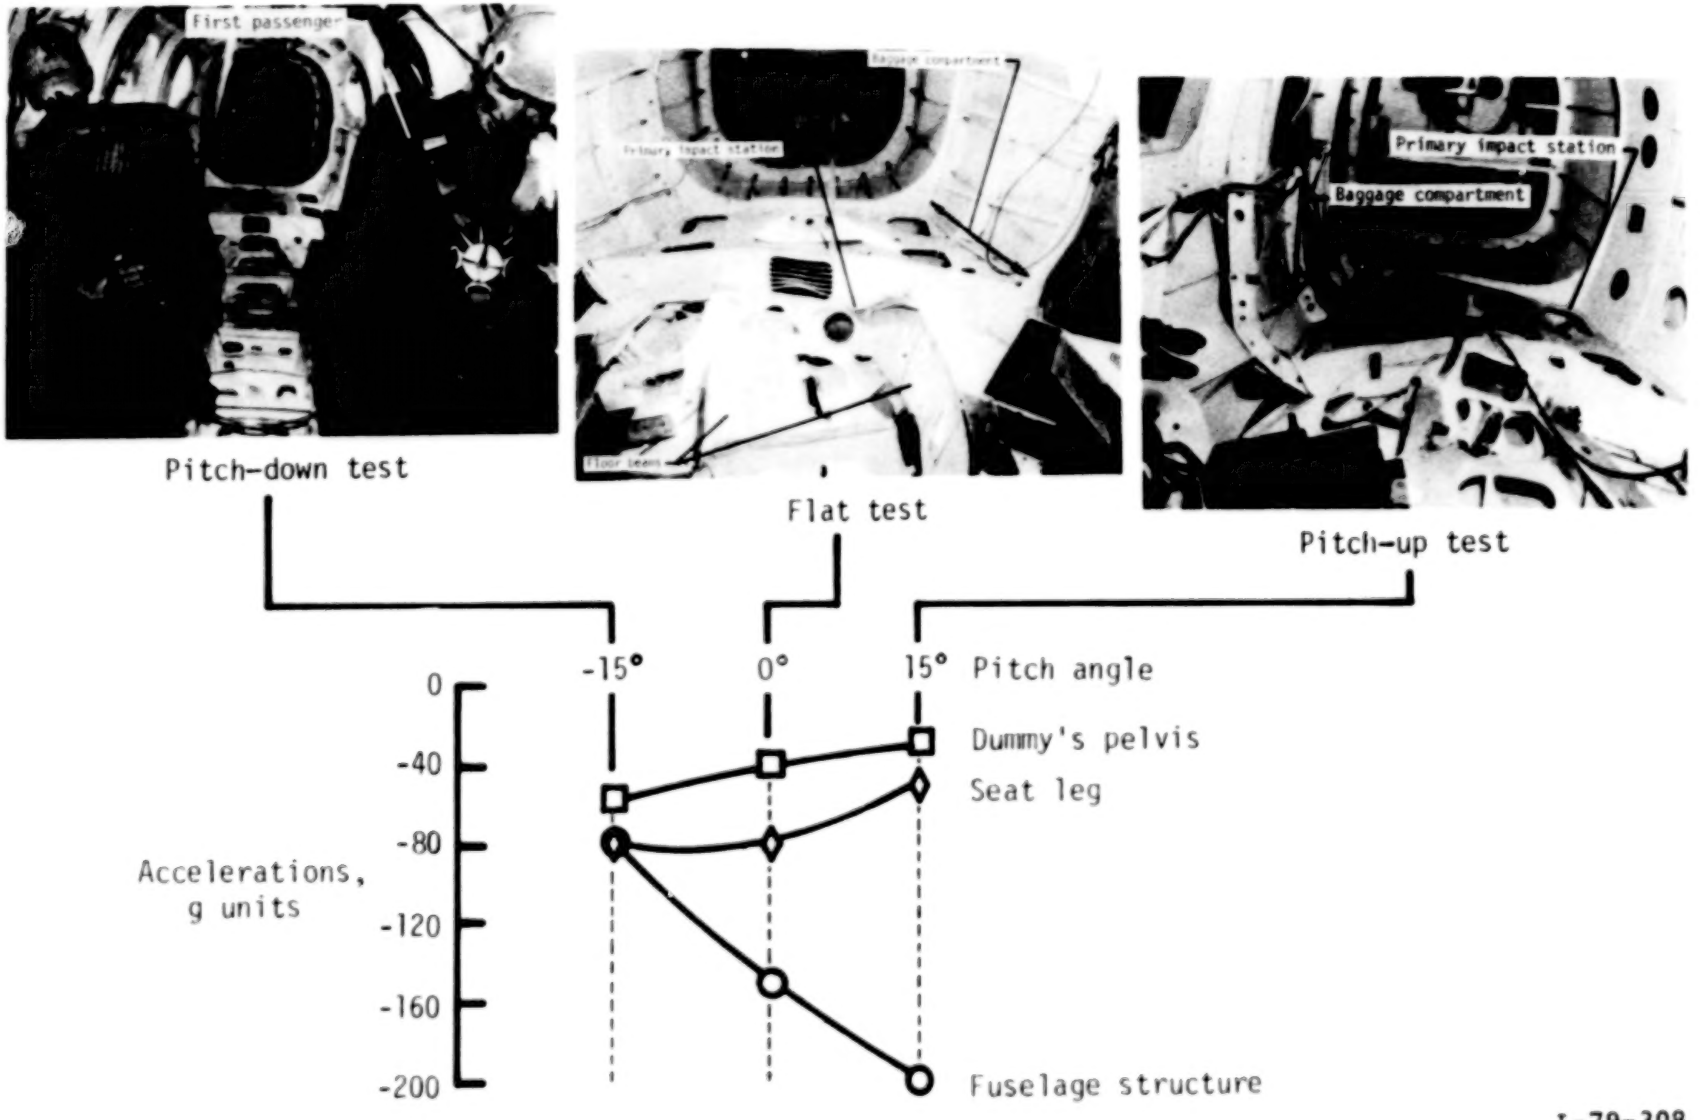
partment floor (fig. 25) are caused by the combination of pitch attitude of the airplane at ground contact, the airplane structural deformation aft of the first-passenger seat, the dynamic reactions of the dummy in the seat, and the changing attitude of the airplane during impact. Because the kinetic energy at impact is the same for the three test specimens, the lower acceleration peaks at the seat legs can be mainly attributed to structural deformation aft of the seat. This is reflected in the lower values of first-passenger seat-leg accelerations (table II). The acceleration differences between the floor at the seat legs and those in the pelvic region of the first-passenger dummy can be as much as 40g.

The difference in physical damage to the passenger compartments that accompanied these accelerations is presented by the photographs in figure 25. The damage increased from the pitch-down to pitch-up tests. The peak accelerations in the pelvic region of the first-passenger dummy decreased from -55g, to -40g, to -30g for the pitch-down, flat, and pitch-up tests, respectively. As the fuselage structural damage increased, peak pelvic accelerations in the first-passenger dummy decreased.

Figure 25.- Maximum normal accelerations in dummy's pelvis, on the floor at the first-passenger seat legs, and on fuselage structure.
